Timber windows: avoiding common failures

Water ingress around glazing

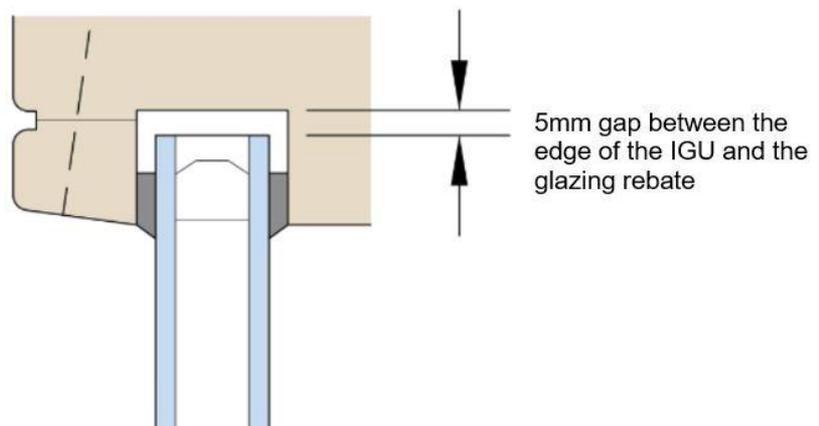
Section through head detail

The IGU has been set too close or touching the rebates of the frame and inhibits the drainage of water. A 5mm drainage path between the edge of the IGU and the rebate should be provided all round the IGU perimeter as this space allows any water that does penetrate seals to run to the bottom of the glazed area where it can drain out.

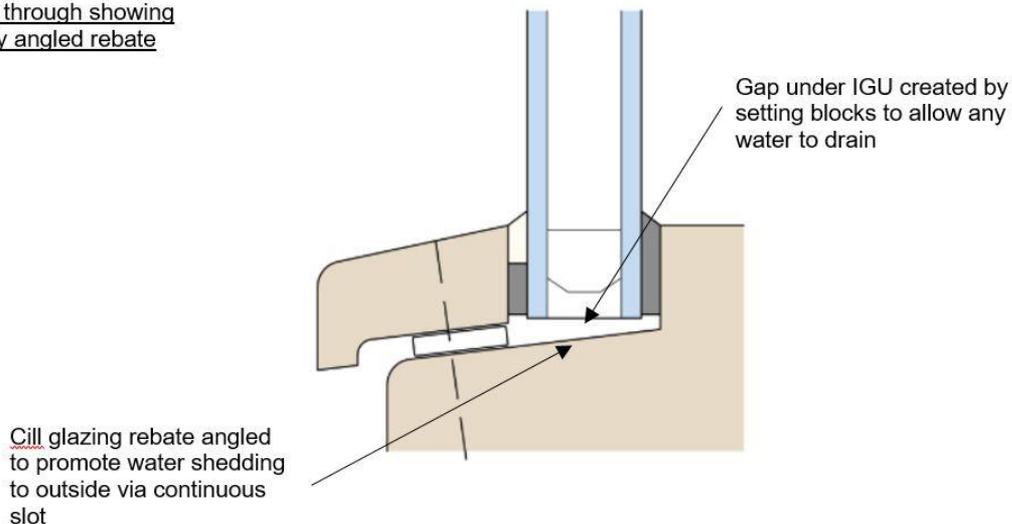
Section through showing correctly angled rebate

IGUs should be set into position using location and setting blocks. These blocks should be placed at intervals around the perimeter of the IGU. The spaces in between allow for any penetrating moisture to run to the bottom rebate and drain out.

The upper surface area of the cill rebate should be angled at a 1:10 (approximately 5.5° angle) so that any water driven into concealed spaces is directed out to the external face via a continuous drainage slot.

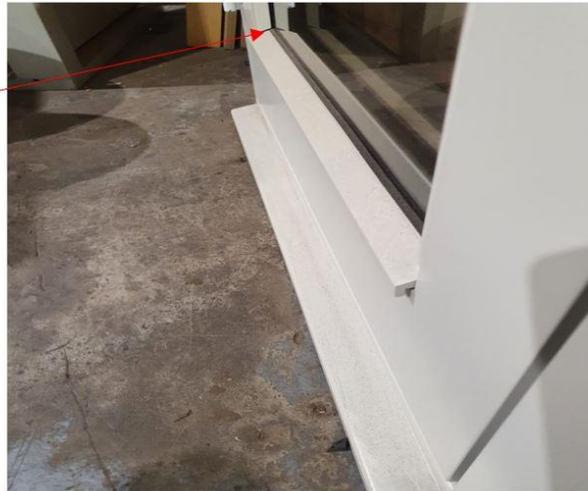
Mitred beading often leads to joints opening in service giving a direct path to moisture at corners. At the junction of bottom bead and vertical beads, water penetrating this area either becomes trapped or is directed into concealed areas of the frame.

Jamb bead cut short, with bottom bead and seals connecting with glazing to ensure water cannot run in through bead joints

To ensure robust and sustained weatherproof details, glazing beads should not be mitred at joints but cut squarely. The top horizontal glazing bead should run the full width of the opening to protect the top of the jamb beads on either side and the wider bottom bead should also run the full width of the opening and project to conceal the drainage weep slot provisions below.

The side (jamb) beads should be cut to stop short of the bottom bead by 3mm – where the bottom bead has a 1:6 (11° angle) weathering slope on its top surface, the gap can be reduced at the glass face by cutting the ends of the side beads to a shallower pitch.
