Timber Windows: Avoiding common failures – window assembly

Ref: TS-3329

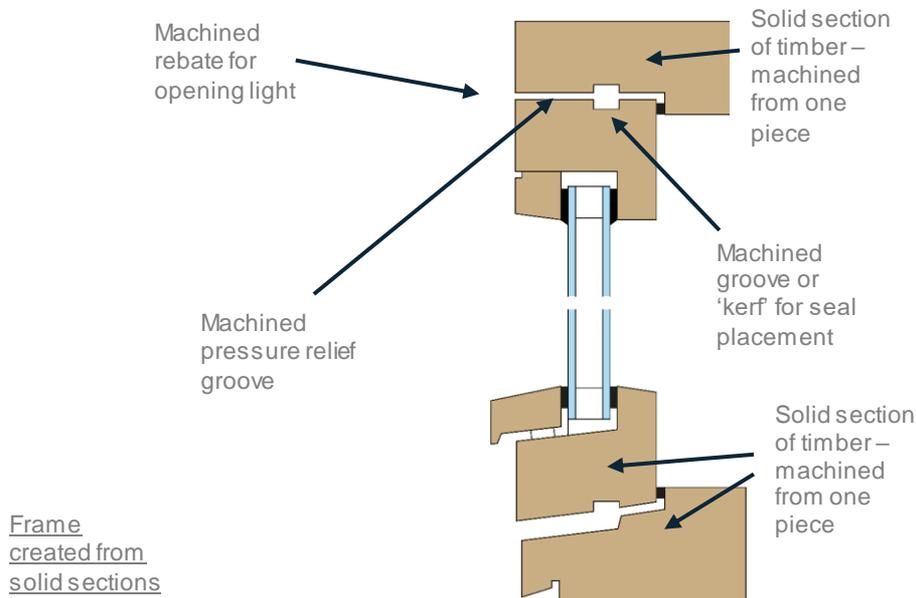
Timber framed windows – machined and manufactured timber frame sections

'Machined' timber frame sections are traditionally produced from solid sections of timber. A square section of timber is taken, and portions removed to give it a functional shape or 'profile'. The removal of an area of timber from the the solid section is known as creating a 'rebate' and this then can receive glazing or opposing rebates are used to facilitate opening portions of the window, arranged and aligned to provide weather protection when the opening light is closed.

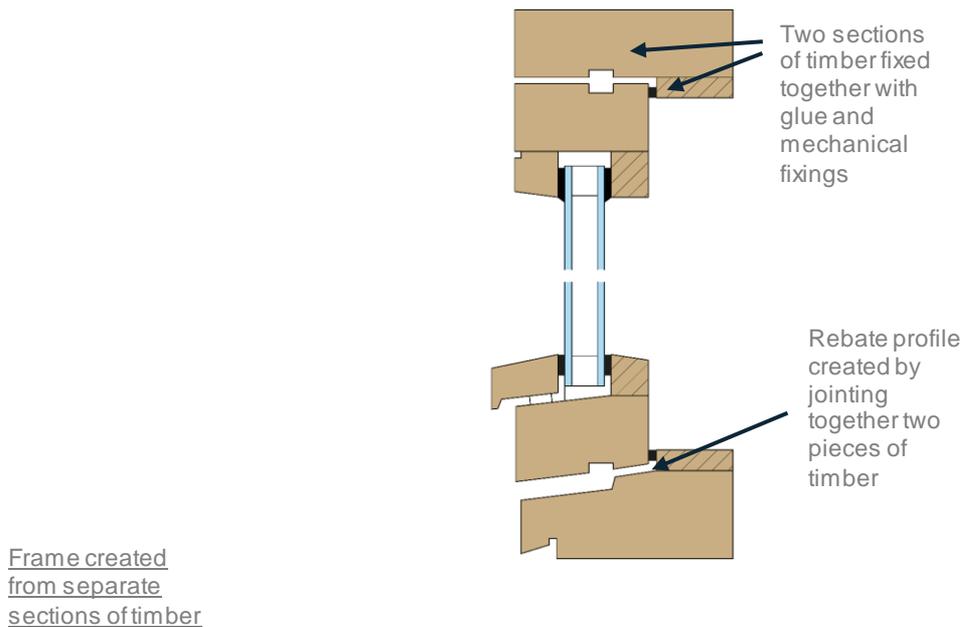
Increasingly suppliers of framing sections are using several sections of timber bonded together using high performance adhesives, and these can be referred to as 'manufactured' timber frame sections. The process can be viewed as a means to reduce waste and improve dimensional stability by orientating grain to reduce the opportunity for risk of twist, shrinkage and warping.

The practice of 'manufacturing' timber frame sections in uncontrolled environments e.g. off-site in workshops not using the correct methodology and machinery, or 'ad-hoc' carpentry window 'build-ups' being created on-site, is resulting in timber window failures in service.

Investigations into these failures has revealed that the joints created between timbers are:

- Incorrectly positioned in relation to exposure to weather (generally considered as the first 40mm from the external face of the frame),
- Not formed in keeping with good carpentry practices or not bonded with adhesive - most are simply pinned or nailed into position. Even where adhesives have been used, they are often incorrect in their specification and do not perform as required.

As a result, any water collecting within the rebate section of the frame freely passes between timber sections and appears on the internal face of the timber frame as staining or as physical water deposits on window boards and adjacent surfaces.

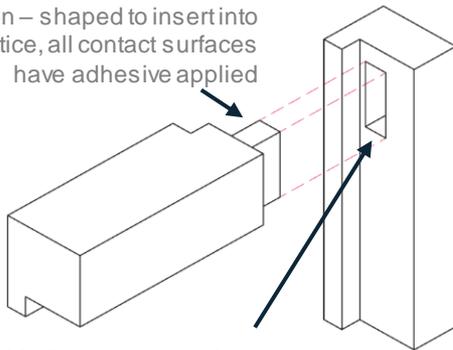
Framing joint – Mortice and Tenon

Tenon – shaped to insert into mortice, all contact surfaces have adhesive applied

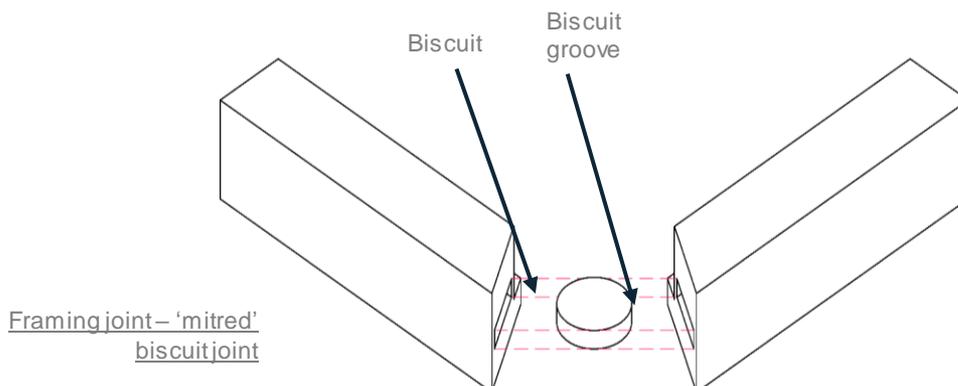
Framing joint – 'mitred' biscuit joint

Increasingly however the use of the timber frame joints that are created differently to those with intersecting elements are now becoming more regular. This method uses profile scribed butt joints or mitres, to create the joint.

A 'biscuit' (biscuits are pieces of pre-made oval shaped timber) and adhesive completes the joint. The biscuit increases the surface area for adhesive, and creates an intersecting part to the joint.
