# Timber Windows: Avoiding Common Failures – Water Ingress Around Glazing

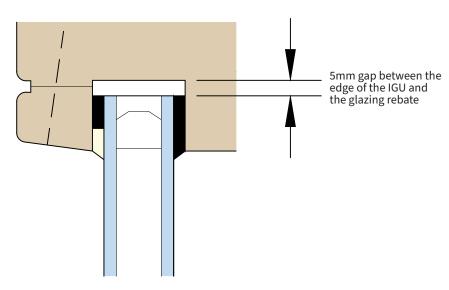
Section through head detail

The IGU has been set too close or touching the rebates of the frame and inhibits the drainage of water. A 5mm drainage path between the edge of the IGU and the rebate should be provided all round the IGU perimeter as this space allows any water that does penetrate seals to run to the bottom of the glazed area where it can drain out.

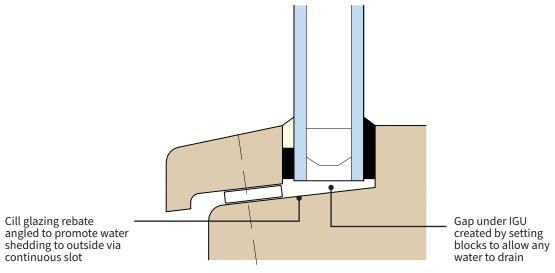
Section through showing correctly angled rebate

IGUs should be set into position using location and setting blocks. These blocks should be placed at intervals around the perimeter of the IGU. The spaces in between allow for any penetrating moisture to run to the bottom rebate and drain out.

The upper surface area of the cill rebate should be angled at a 1:10 (approximately 5.5° angle) so that any water driven into concealed spaces is directed out to the external face via a continuous drainage slot.

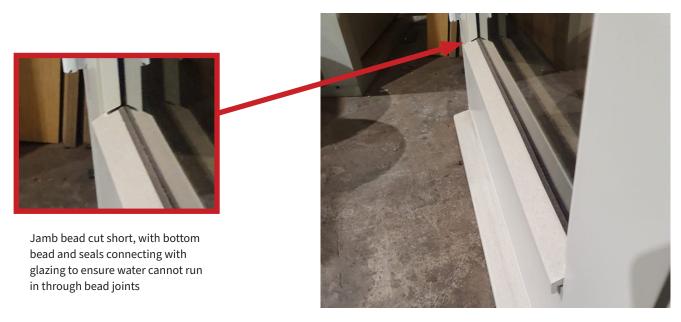
Image showing correctly scribed beading

Mitred beading often leads to joints opening in service giving a direct path to moisture at corners. At the junction of bottom bead and vertical beads, water penetrating this area either becomes trapped or is directed into concealed areas of the frame.

To ensure robust and sustained weatherproof details, glazing beads should not be mitred at joints but cut squarely. The top horizontal glazing bead should run the full width of the opening to protect the top of the jamb beads on either side and the wider bottom bead should also run the full width of the opening and project to conceal the drainage weep slot provisions below.

The side (jamb) beads should be cut to stop short of the bottom bead by 3mm – where the bottom bead has a 1:6 (11° angle) weathering slope on its top surface, the gap can be reduced at the glass face by cutting the ends of the side beads to a shallower pitch.
